Project Title:	System for vehicle-infrastructure Interaction Assets health status monitoring
Starting date:	01/03/2018
Duration in months:	42
Call (part) identifier:	H2020-GALILEO-GSA-2017-1
Grant agreement no:	776402

Deliverables D8.1

Test Setup Description

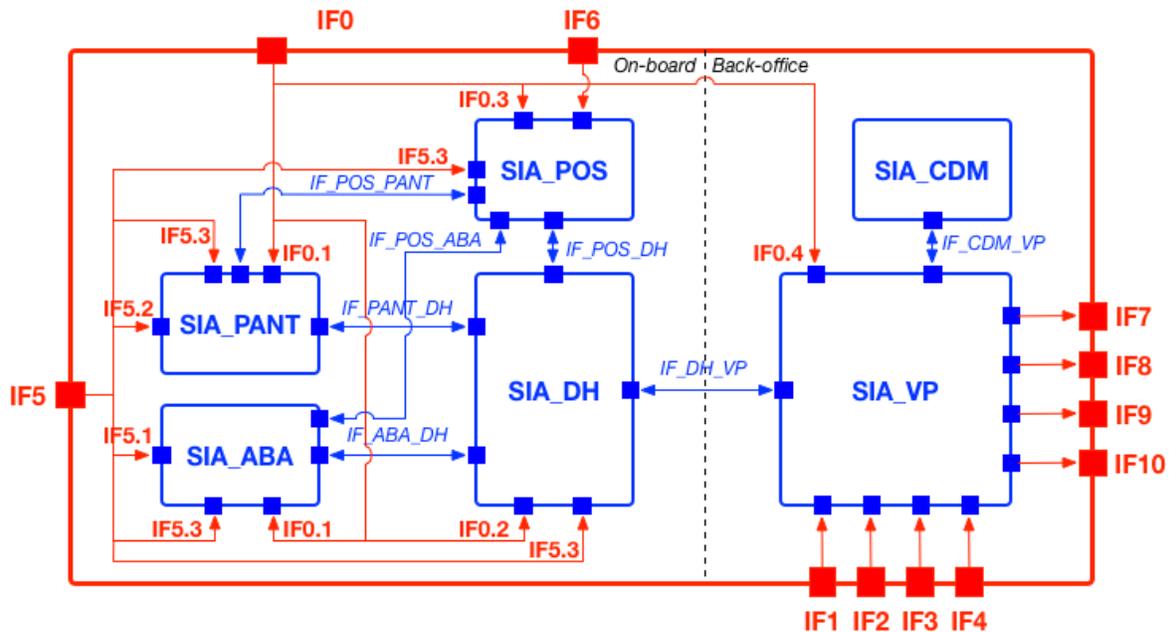
Figure 3-1: SIA Architecture

As a visual representation of the above subsystems, the following diagram has been created to define the overall architecture and the associated interfaces of the SIA system.

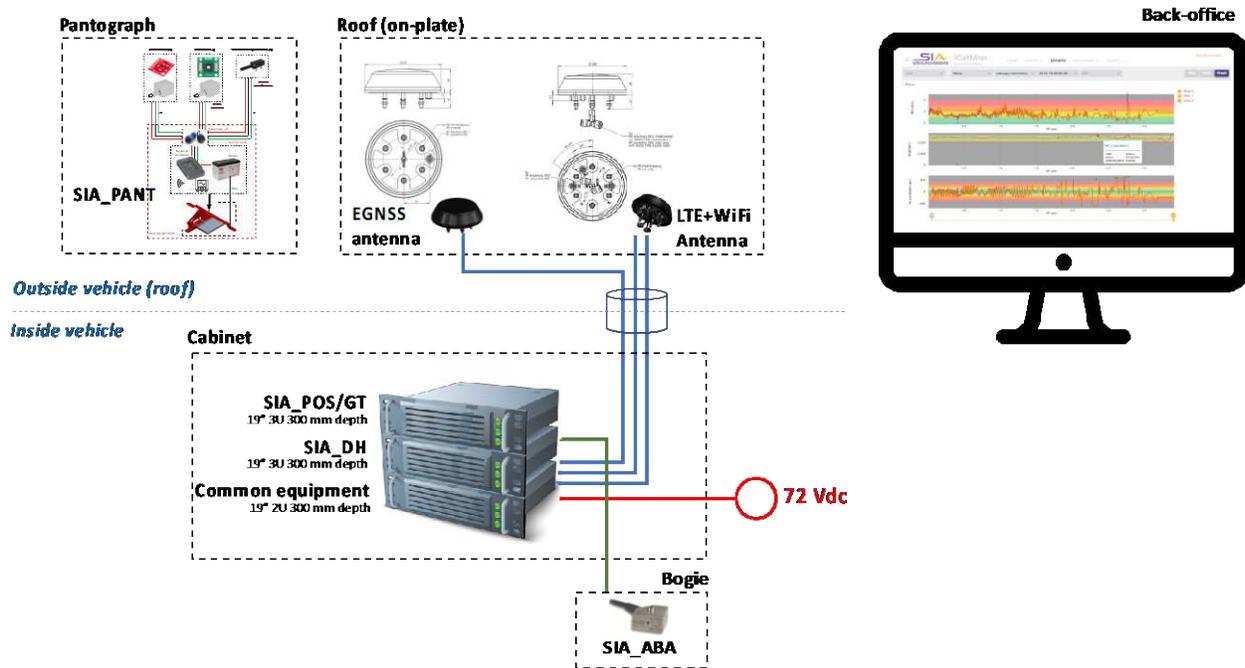
Figure 3-2. SIA system (simplified) Hardware architecture

The on-board data integration platform and train-track communication hub. On the other hand, the hardware specific version of the architecture is shown in Figure 3-2. It represents the main pieces of equipment, their location, whether they are out of the vehicle (roof) or inside the vehicle (cabinet), and how they are connected with each other.

As it can be seen that the antennas and SIA_ABA subsystem are wired to the equipment in the cabinet. As the system installed in the pantograph (SIA_PANT) is fully wireless, and the connection with the visualization platform (SIA_VP) is also wireless.

The drawings inside Figure 3-2 are blurry for qualitative description purposes. The system is composed by the following main items, whose installation will be explained further in subsequent chapters.

The system to be validated in the FGC scenario is the one described in Figure 3-2.

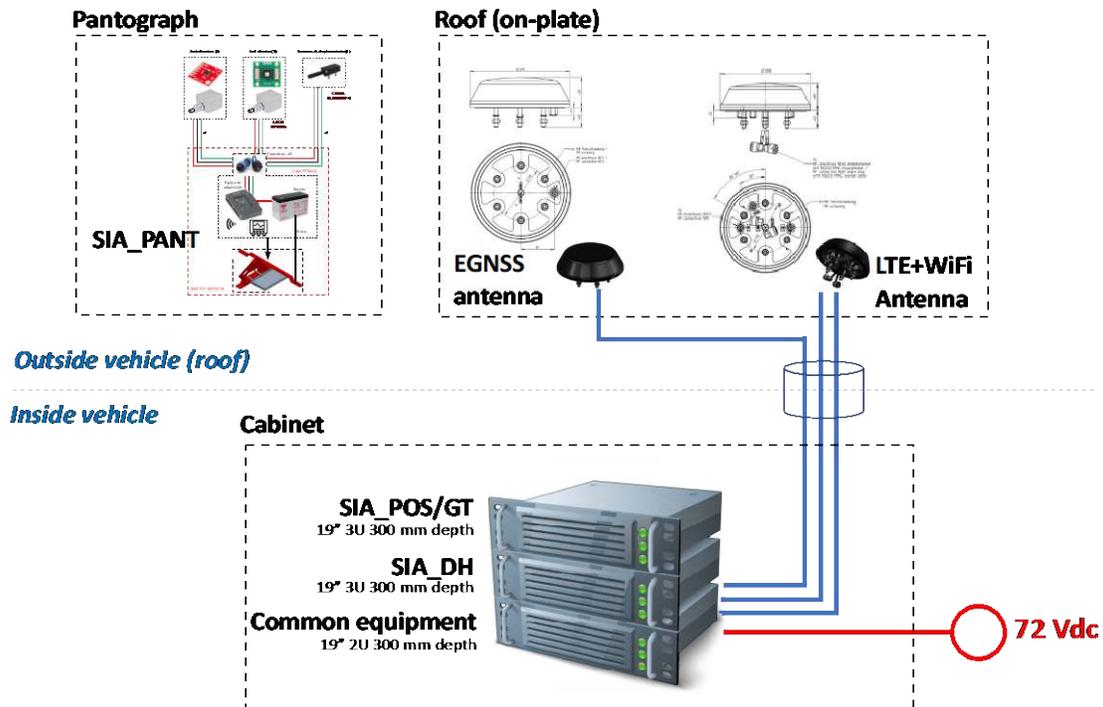
Figure 4-3. Installation overview. Source: CEIT.

Above is shown the general overview of the installation of the system. There are three main locations for the installation of the equipment

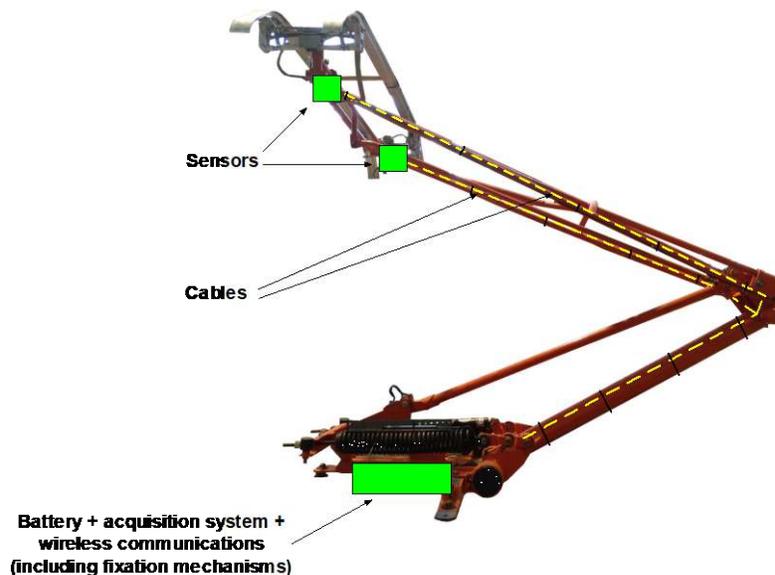
Figure 1. Pantograph system simplified architecture. Source: CEIT.

The system does not have a physical connection with the equipment installed in the cabin neither in the roof. Data collected by the system is sent wirelessly to the equipment installed inside the cabin of the train. The qualitative scheme of the system and their representative components are depicted in the following figure.

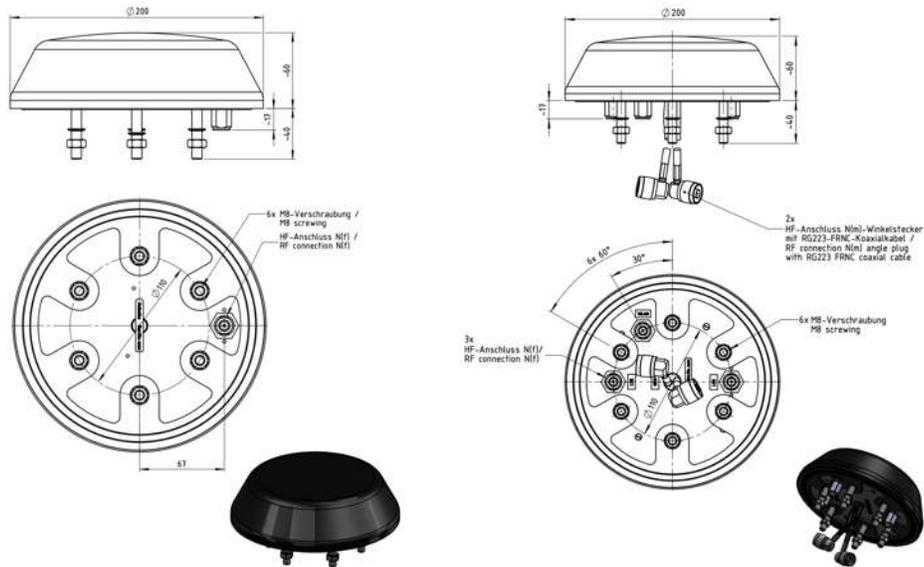
Figure 4-4. EGNSS antenna and Wi-Fi and LTE antenna

The three cables connecting the antennas will be pulled out from the side of the junction box using watertight connectors and corrugation to the bottom of the extension board to connect to the antennas.

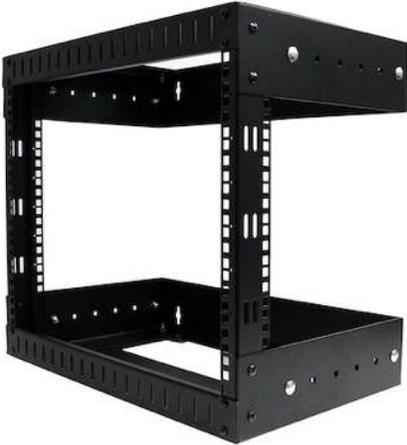
Figure 4-6. Open frame rack for the installation of 19” rack units

In order to adapt the SIA equipment to the new available space and using the same 19" Rack format, it will be mounted inside an 8 U-high open-frame rack from Startech, model [RK812WALLOA](#) (Figure 6-9). This structure offers the possibility of having an adjustable depth from 12" to 20". As can be seen, it would not conflict with the 300mm depth of the existing hole. The distribution of the three units that compose SIA system is shown in Figure 6-10.

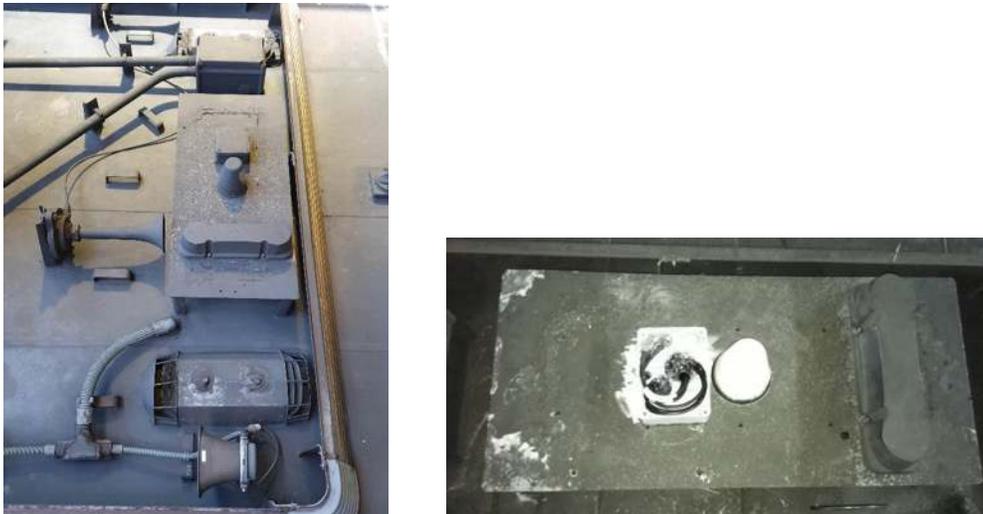
Figure 4-8. Left: Previous situation of the roof. Right: Final situation with new cables.

Aluminothermic welding was done to install the new tube, antennas uninstillation and installation with the corresponding performance protocols were done and cables of SIA antennas were preinstalled. In the following pictures this is shown, on the left, the previous situation of the roof and, on the right, the new connections box with the new cables ready to connect to the SIA antennas.

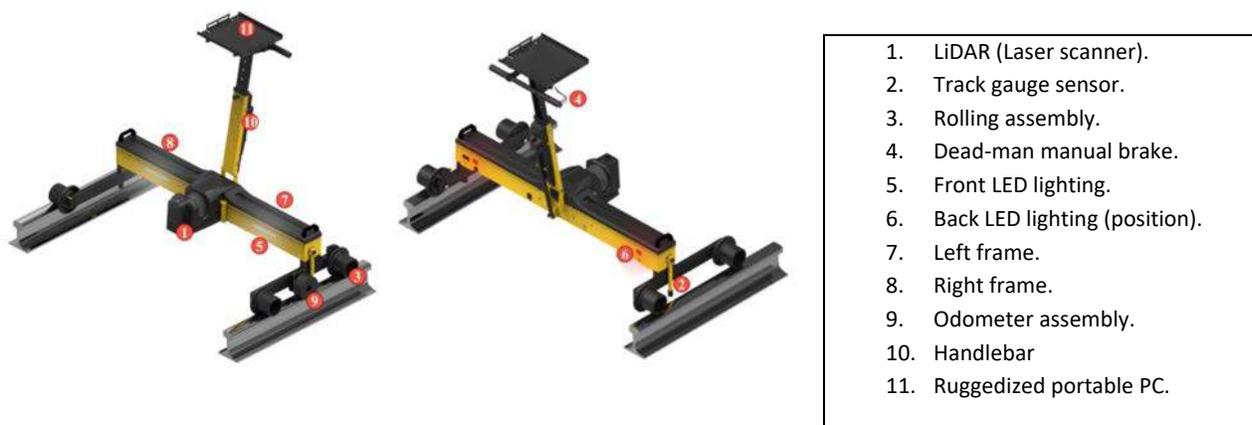
Figure 4-9. tCat® OLE measurement workstation. Source: TELICE.

The tCat® measurement procedure requires the tCat® to be placed on the track and to travel through the area to be measured with stops at the points of interest. The system is equipped with a dead-man brake to prevent uncontrolled rolling.

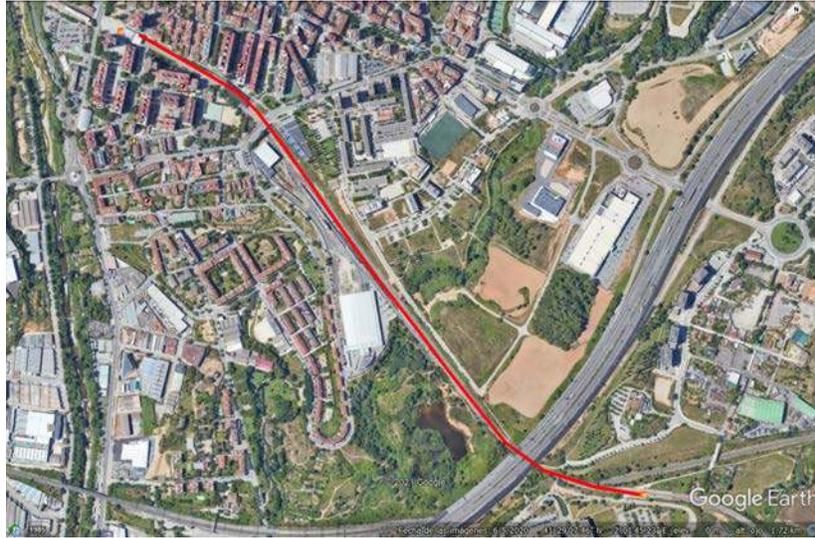
Figure 4-10. Track extent involved in the measurement campaign. Source: TELICE.

Measurements were carried out in track 2, between the stations of Rubí and Hospital General, (milestones 010+397 to 008+970), with a tCat® 1435 system, under all OLE poles.

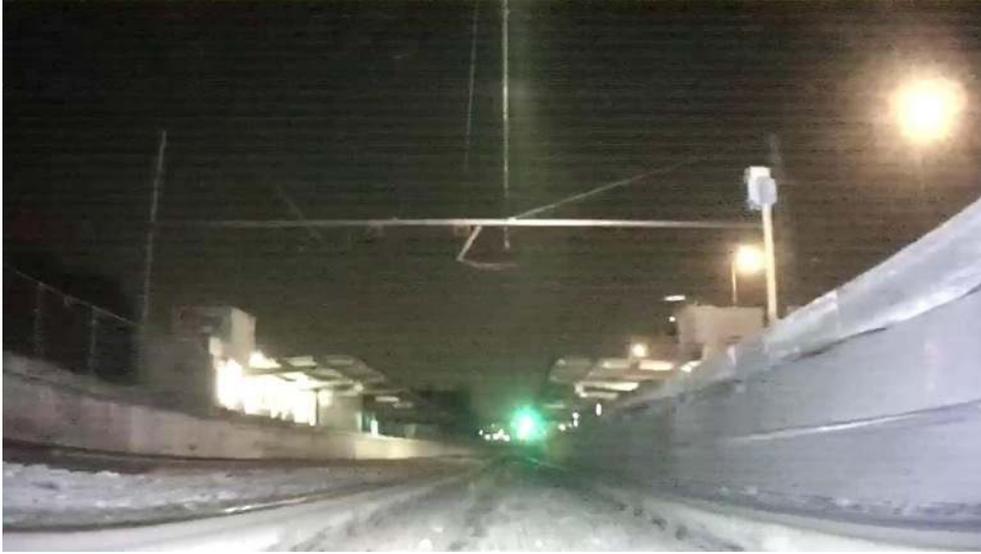
Figure 4-12. Typical tCat® frontal camera capture. Source: TELICE.

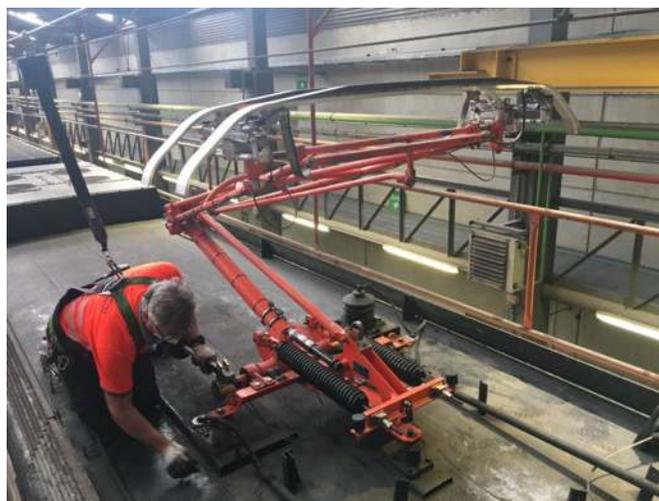
Figure 4-16. Installation of the instrumented pantograph in the vehicle. Source: CEIT and FGC

Once the system was ready, the unit was powered to 1.500 V through the instrumented pantograph, the SIA system performance was correct and a dedicated run in the rail yard of the workshop was completed to ensure that the unit and the system was working properly.

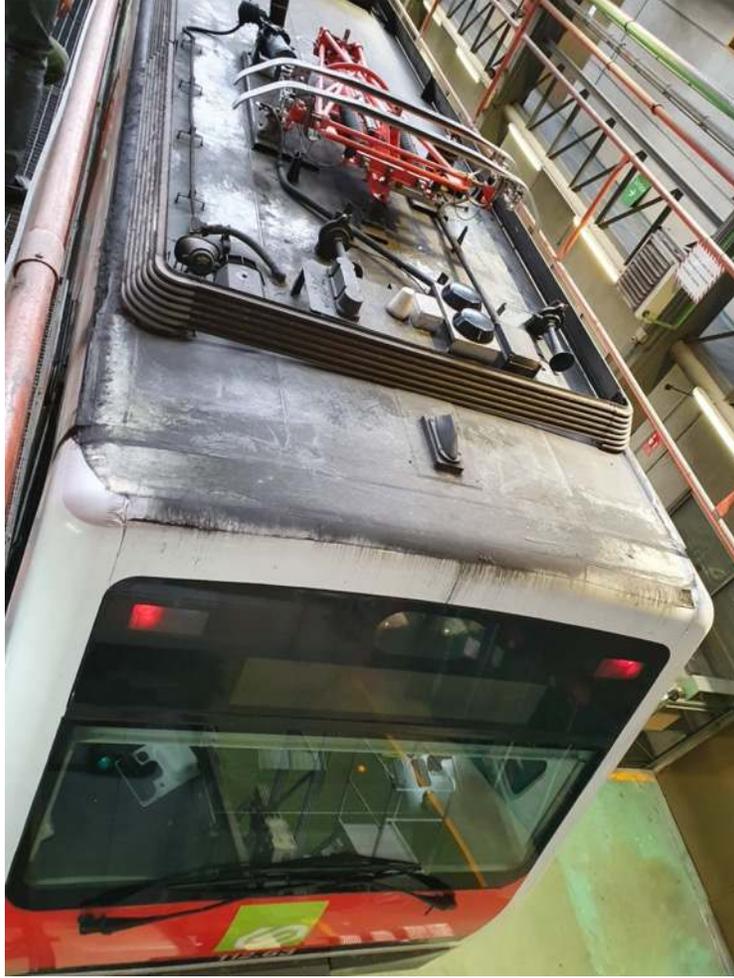
Figure 4-18. SIA complete system installed in FGC train unit. Source: FGC.

The system was tested in real operational conditions initially in a dedicated night run. More precisely in the section of the line where TELICE took measurements of the track and catenary conditions. The track section and an FGC driver were booked for this activity, remote checks and in situ performance of the system were evaluated by CEIT.

From the 8th to the 13th of July, the unit equipped with SIA system ran through the BV line completing different services and routes as agreed with CEIT.

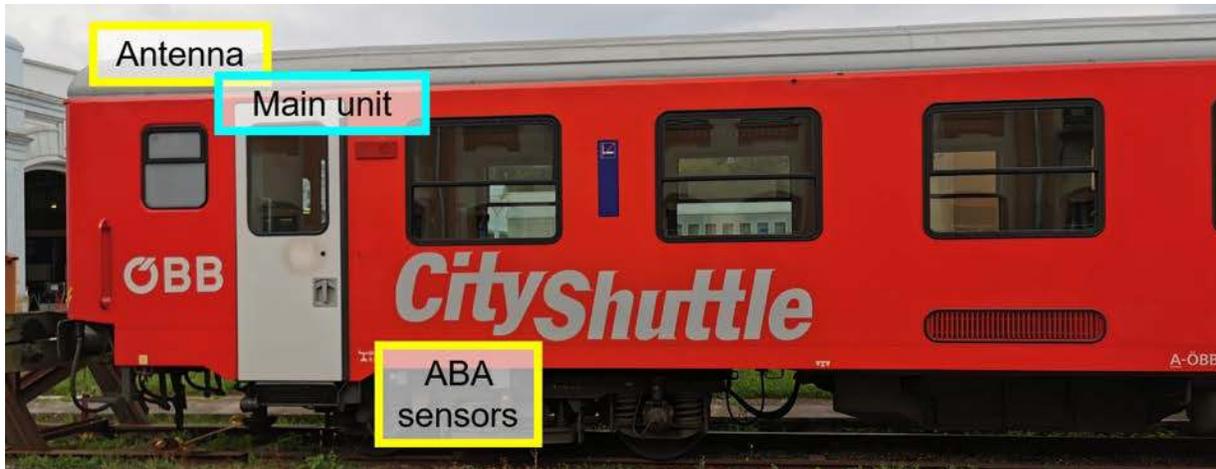
Figure 53, OBB passenger wagon with an overview of sensors and data box.

The installation went well and DLR could verify the proper system operation by remote access to the SIA unit. With a small delay (not related to SIA) the OBB train could resume regular operation on November 11, 2020. In late January the train was again taken to the workshop for an unscheduled and SIA-unrelated maintenance stop for several weeks. Since March 2021 the train and SIA unit are again in full operation at least until August 2021.

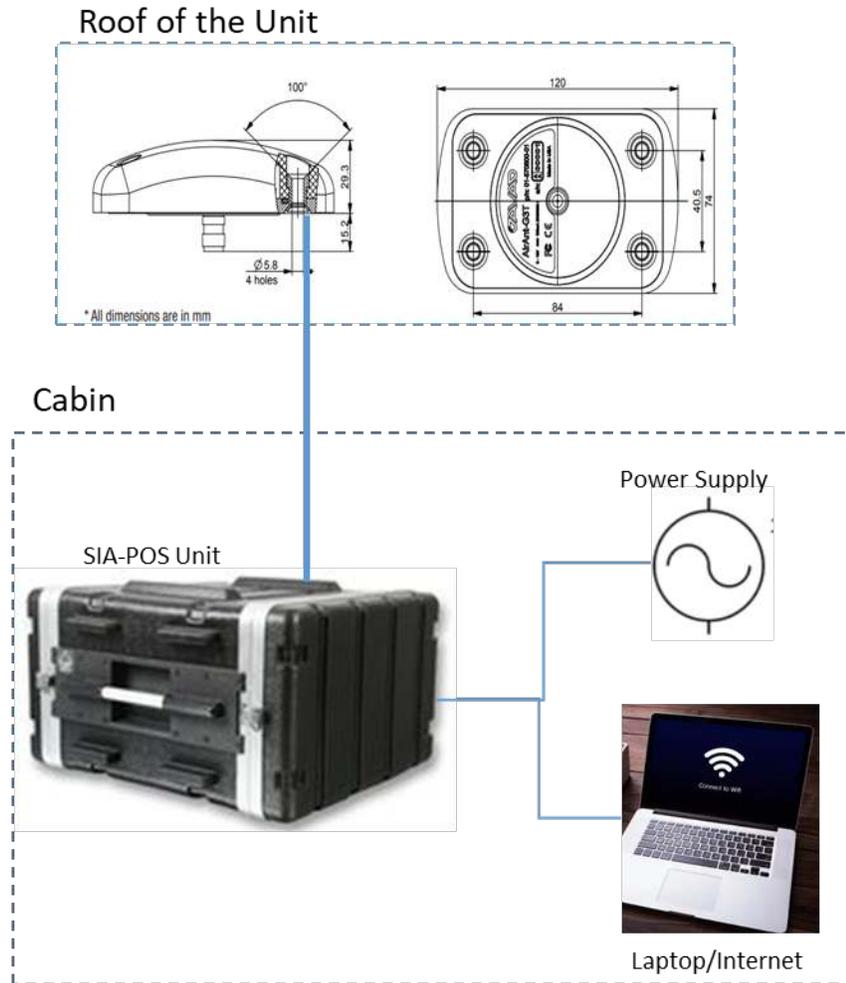
Figure 5-6 SIA-POS Installation overview. Source: OBB.

- GMV NSL SIA-POS unit
- JAVAD AirAnt dual frequency antenna
- Power supply
- Internet connection
- Antenna cable
- Power cable
- Ethernet cable

There are two main locations where SIA equipment was installed for this test, the roof of the train and inside a train cabin.

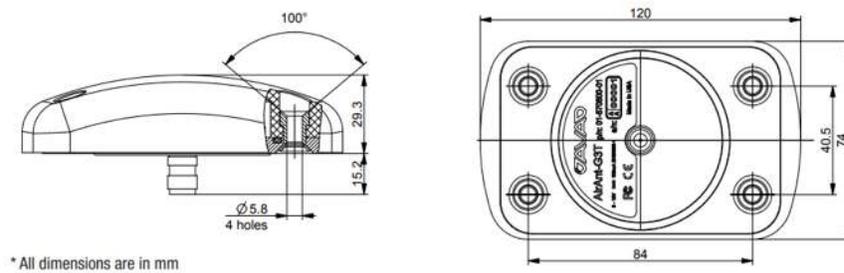
Figure 5-7 Javad AirAnt Antenna Schematic

* All dimensions are in mm

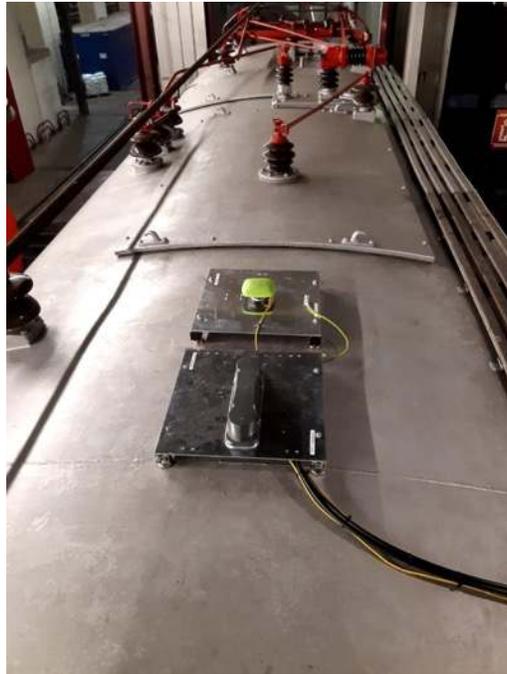
Figure 5-8 Magnetic plate on the roof of the test Unit. Source OBB.

To install the antenna, on the roof of the unit there is an existing magnetic plate where the antenna could be mounted. (Figure 5-5). A Javad AirAnt was used for this test.

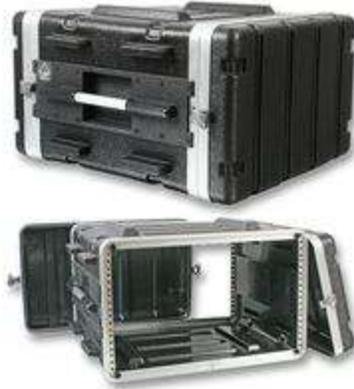
Figure 5-9: SIA POS Enclosure

The entire SIA POS system (except the antenna) is fitted within a flight case shown as below.

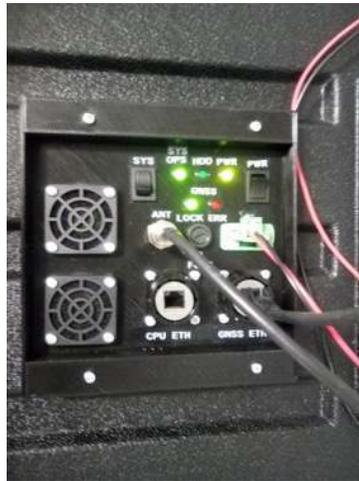
Figure 5-10: Control panel on top of unit with power supplied, Ethernet cable connected to GNSS board and GNSS cable connected.

For the installation, the SIA_POS unit was mounted on the train in a manner deemed suitable. There is an arrow on the unit that indicates the direction of travel in relation to the IMU inside. This arrow must be pointing towards the direction the train will move in so the IMU is orientated correctly. The control panel is on the top of the unit.

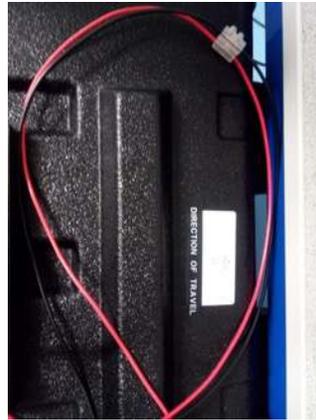
Figure 5-11: Direction of travel marker on top of unit (in this instance, direction of travel is to the right of the picture)

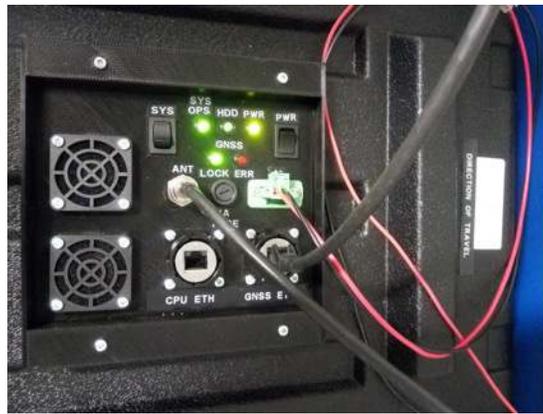
Figure 5-12: Control Panel in relation to direction of travel marker unit (in this instance, direction of travel is to the right of the picture).

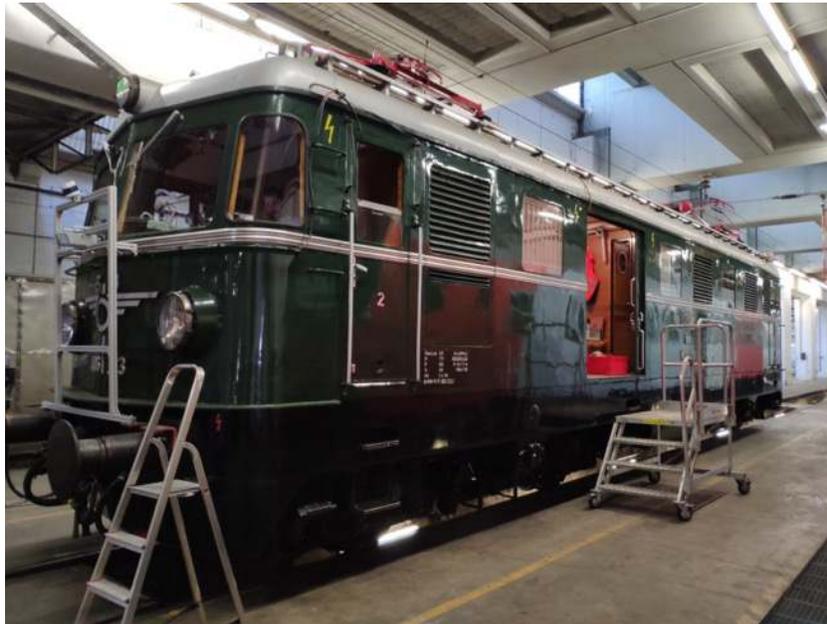
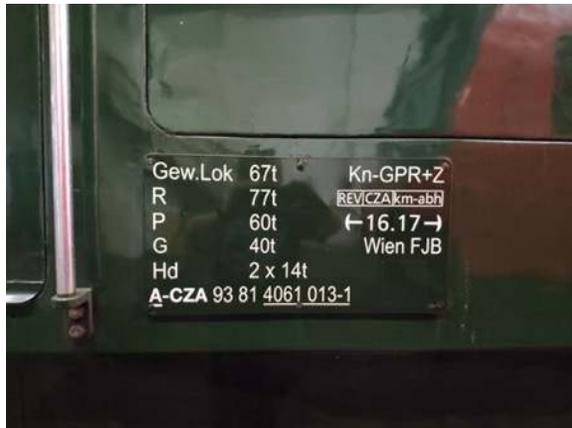
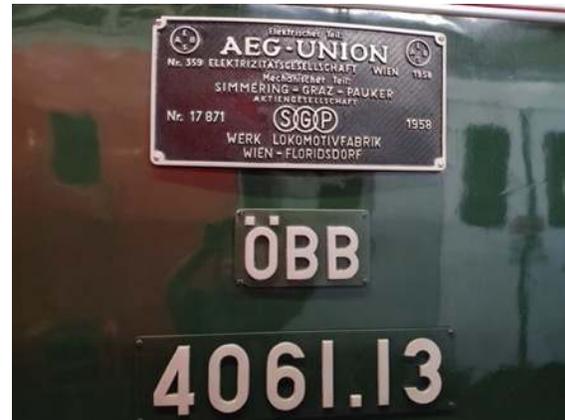
Figure 5-13 Vehicle used for OBB scenario. Source: OBB.

As mentioned above, for this test with OBB, the SIA-POS (Positioning) Unit was installed inside the train cabin along with a dual frequency GNSS antenna on the roof of the train. It is noted that the SIA-POS unit in the OBB scenario is different in dimension from the one which was used in the FGC test scenario.

For the test run, the SIA-POS was setup in the locomotive and was tested in real operational conditions on 21st July 2021. The trial run was only for an hour and the main purpose was to check that all equipment/connections (including the SIA-POS unit, the antenna, and the power supply and internet connection) were working properly ready for the longer data collection activity. After a successful trial run, a final check was done in the workshop to confirm that the unit is ready for the final test.

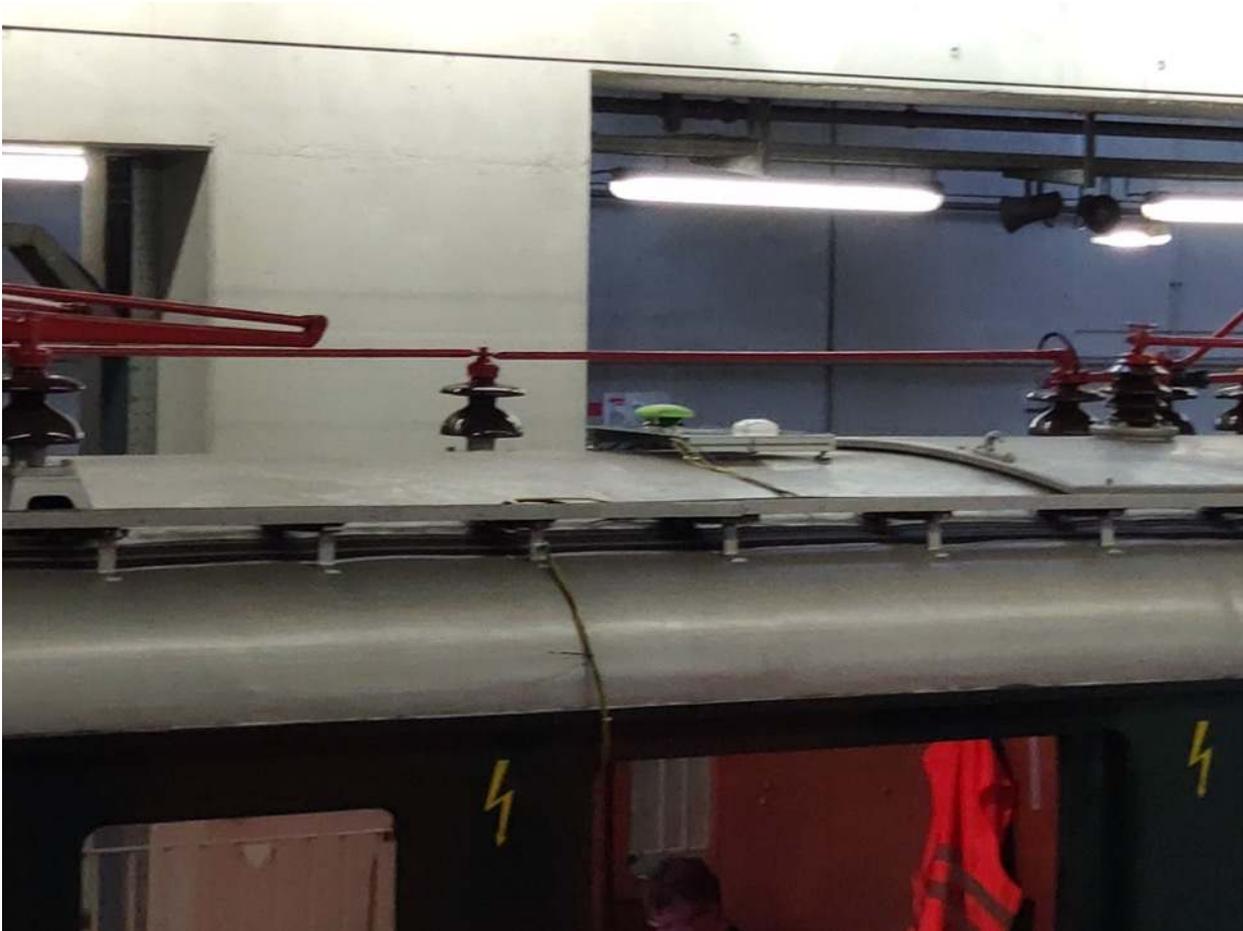
Figure 5-14. Installation of antenna on the roof. Javad AirAnt antenna in white. Source: ÖBB.

The GNSS antenna is fixed to the roof of the train using a magnetic mount. The antenna and the box must be installed on the same coach. The antenna cable is passed from the roof to the coach through the door joints and connected to the SIA_POS unit.

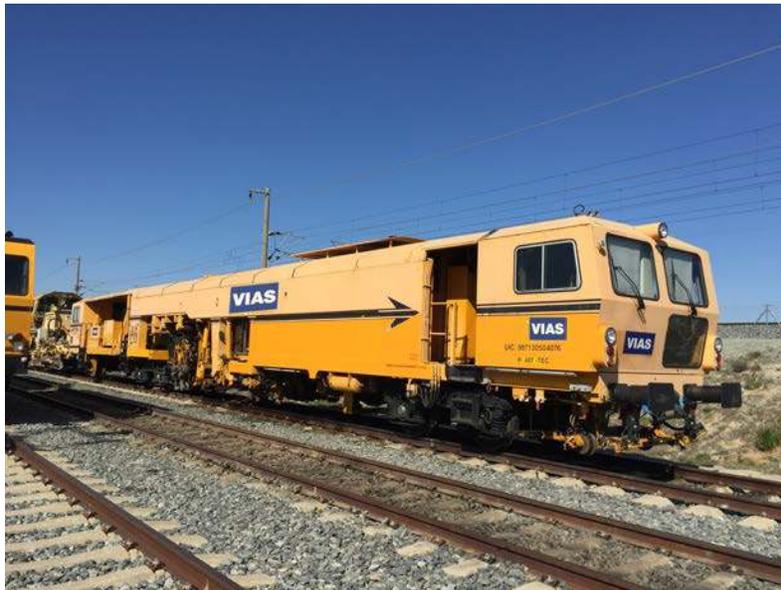
- SIA_PANT: only accelerometers were installed in the bogie of the vehicle, to test the functionality of the acquisition system and the reliability of sensors in a harsh environment. Apart from that, the complete hardware of SIA_PANT as described in D4.1 was installed.
- SIA_POS. A first prototype unit was installed inside the cabin of the vehicle.
- SIA_DH. A preliminary prototype unit of SIA_DH was installed also inside the cabin of the vehicle and connected to SIA_POS.

Figure 6-2. Vehicle used for VIAS scenario. Source: VIAS.
